OFF SITE WORKS

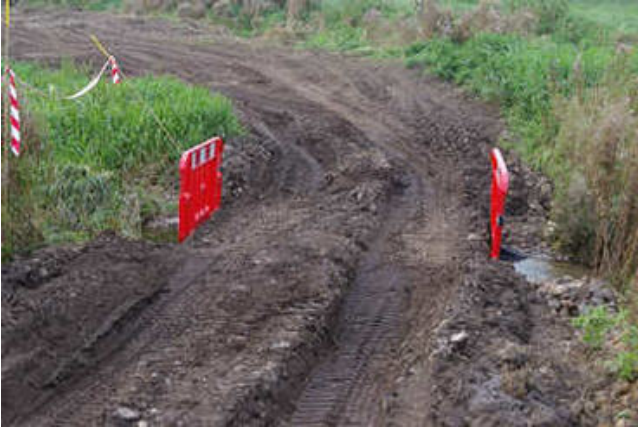
Temporary bridge across side channel, installed 11/10 after a shower of rain
[16/10]

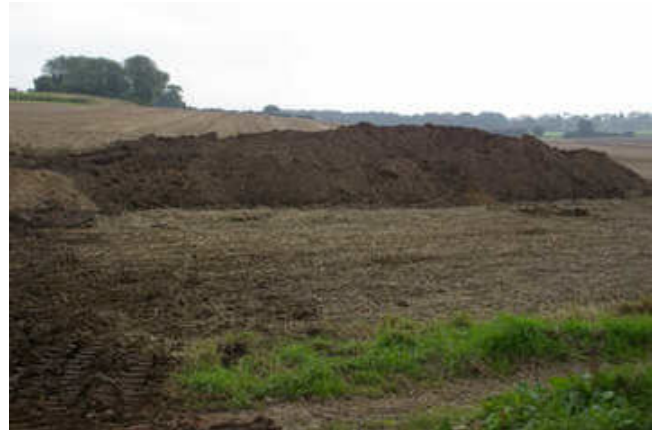
Spoil was deposited on arable field. Large stone was removed by hand either at meadow or field end
[16/10]

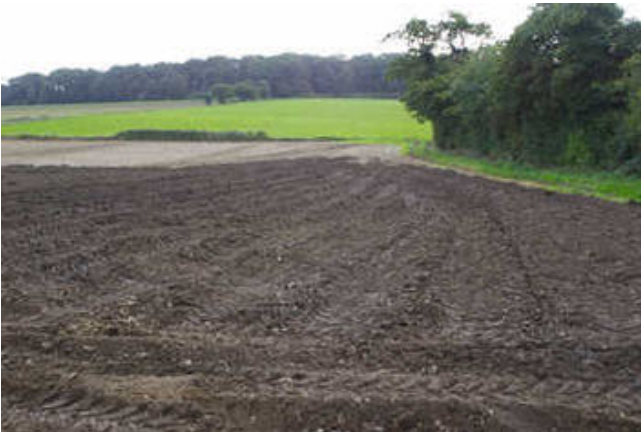
Spread soil ploughed in
[07/12]

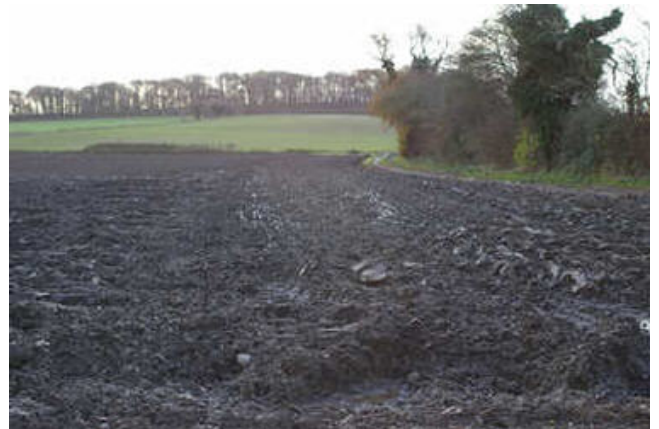
Spread soil ploughed in
[07/12]

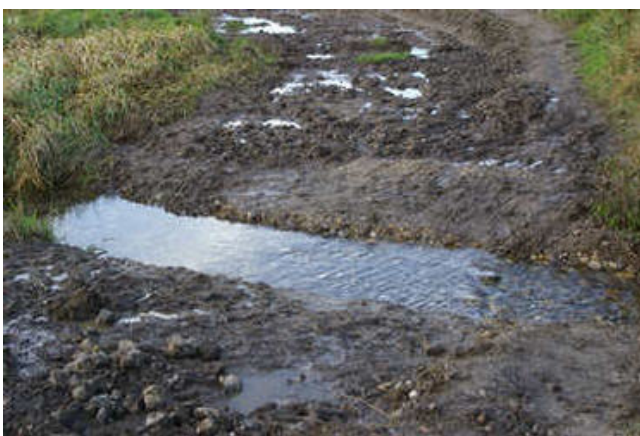
Final stages of re-instating side channel approaches; recovered large flint was used in cattle crossing 3
[07/12]

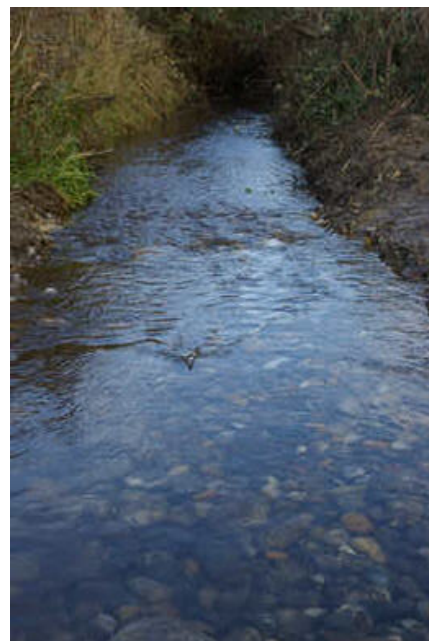
Small stone recovered was used to re-instate stream bed at the crossing, and Extend upstream and (shown) downstream
[07/12]
