# BANK RESTORATION

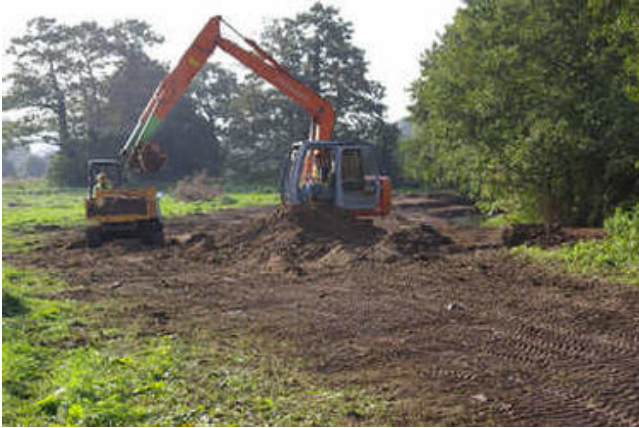
Spoil removal by tracked digger and 2 dumpers working in tandem  
[11/10]

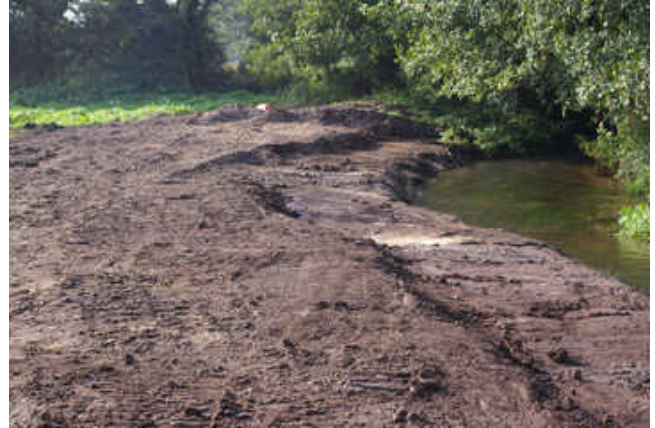
Re-profiled river bank, upstream end  
[11/10]

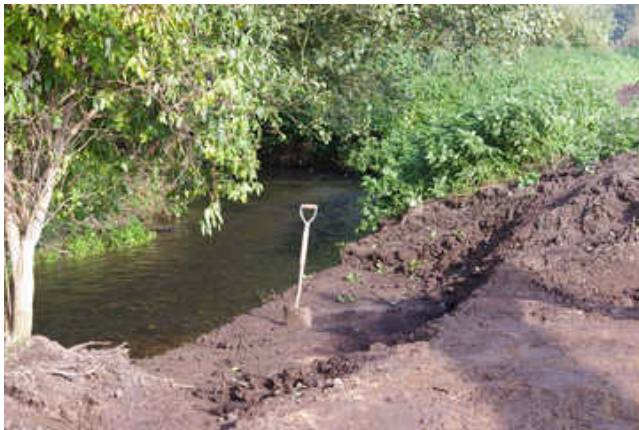
Re-profiling the river bank (the shovel is to clean the digger bucket!)  
[11/10]

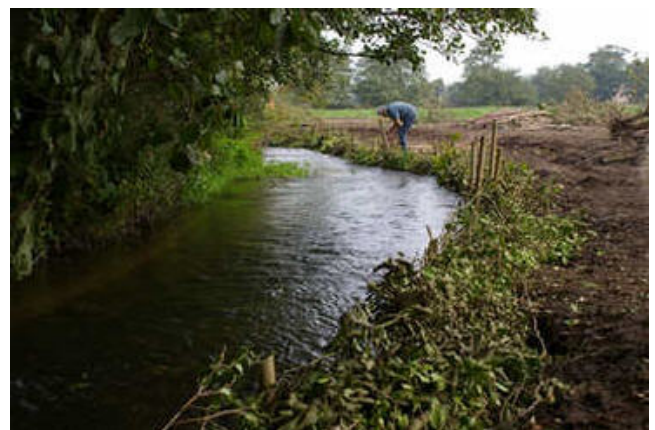
Protection of the re-profiled bank against erosion in flood until vegetation is re-established (technique as for river narrowing)  
[16/10]

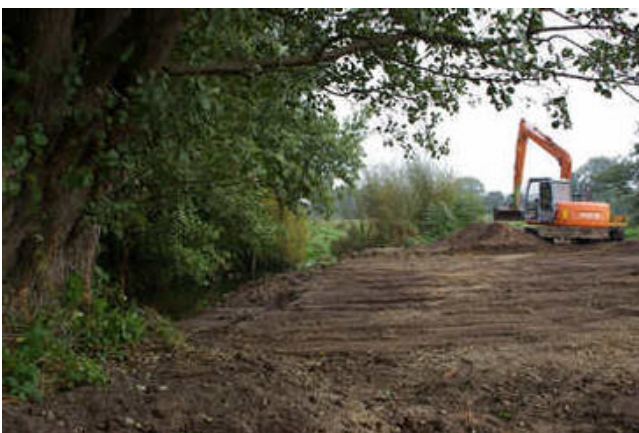
Digger working on final (downstream) stretch of spoil removal  
[16/10]

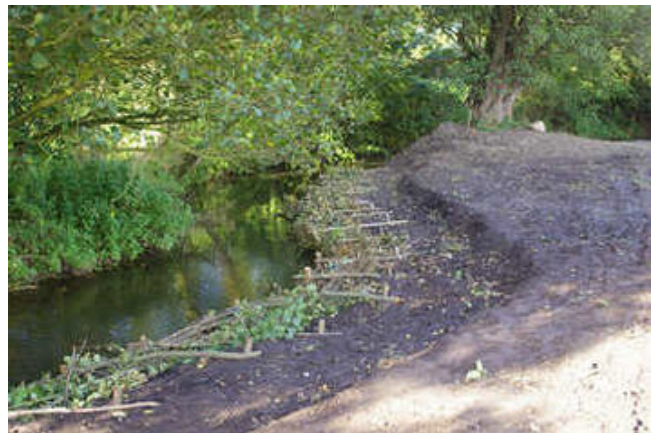
Bank protection around the old alder, tree 1  
[21/10]

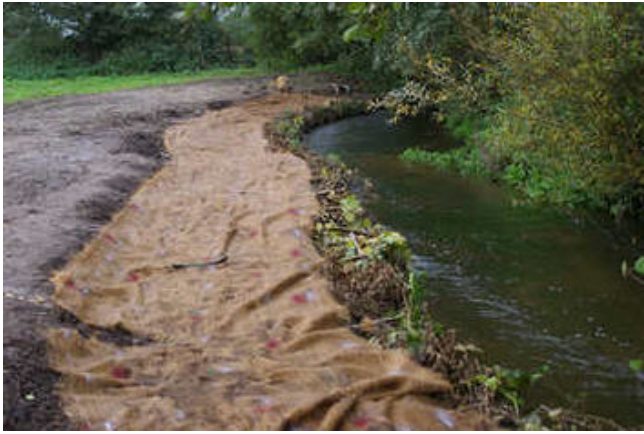
Bank protection, upstream section  
[25/10]

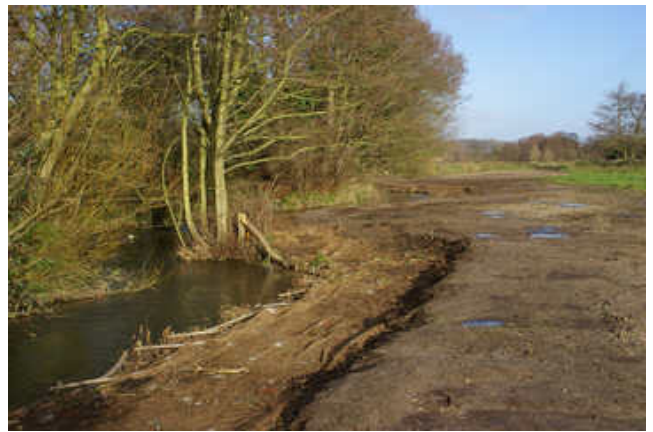
View 6 weeks after work completion. Shows  
the shape of the river revealed, the area of  
spoil coverage, and bank protection  
[07/12]

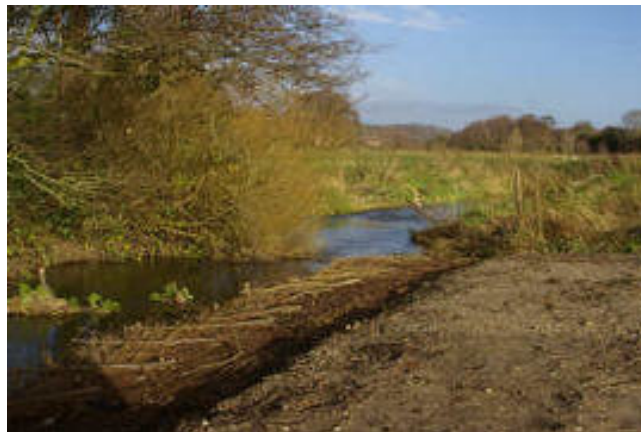
Close up of bank protection, which was  
finished with the coir matting to prevent  
soil loss in flood and will allow vegetation  
to grow through. Also shows LWD 9 and  
cattle crossing 3; latter done by hand with  
recovered stone and "gleaned" gravel  
[07/12]
