RGCG Newsletter April 2007

CINDERELLA CHALK RIVERS PROJECT

River Restoration Work in Action.

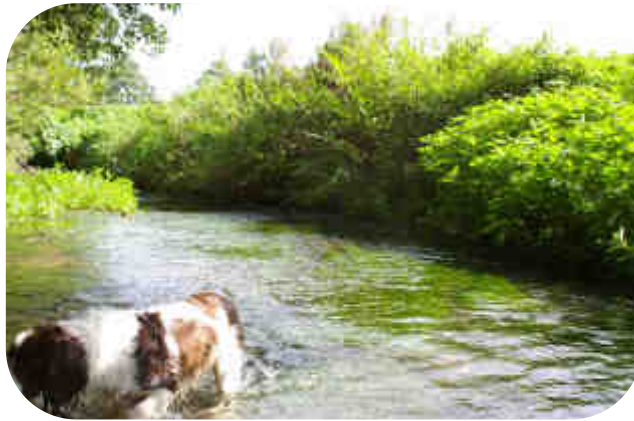
Spoil bank before re-profiling work.

The Environment Agency removed some 700-1,000 tonnes of spoil bank from a 130m length of river bank on one meadow. The river bank was restored to a natural profile, and by doing so re-connected the river with the meadow, which can act as a flood plain in a one in 3-4 year severe rain event. The spoil was a decent soil, and was taken to a nearby arable field where it was later spread and ploughed in.

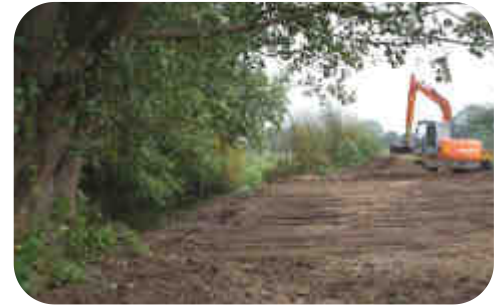
Positioning bank protection

the large woody debris requirements. The posts, faggots, batons and brash used for river narrowing, island construction and bank protection work were produced by coppicing hazel trees on site or nearby. The stone came from local sources, both less than three miles from the site, as did the gravel. Some more stone was recovered by hand from the spoil.

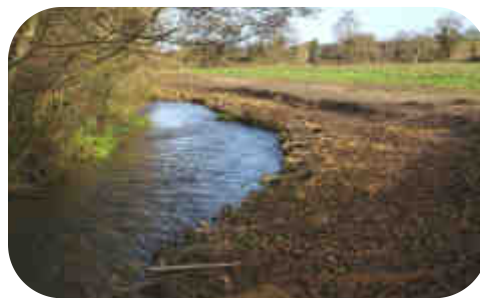
Work in progress

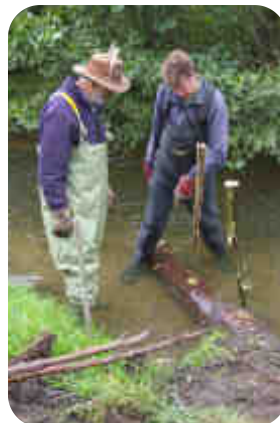
Profiling work finished

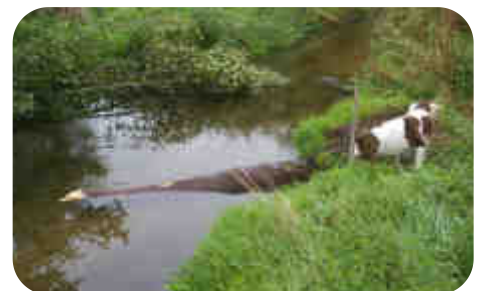
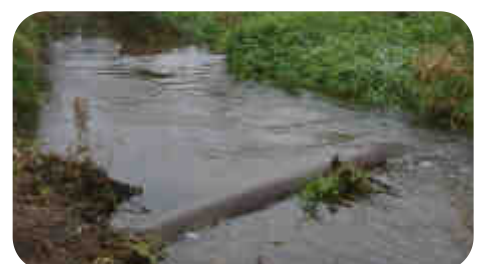
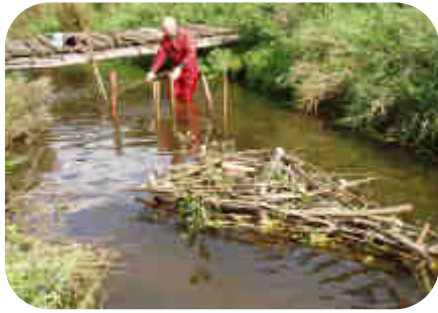
Positioning of Large Woody Debris and examples of finished work

The main river works consisted of the introduction of 6 flint and gravel riffle areas (total length 65m), two of which served a dual function for cattle crossing and drink areas; two lengths of river narrowing, 10m and 13m; the creation of three small mid-stream islands; and nine lengths of tree trunk inserted as large woody debris flow deflectors at a spread of points.

The RGCG are especially pleased with the large woody debris work, and the re-connection of river and meadow. Visitors with an interest in such work have all commented on both, in particular the bank re-profiling and restoration. Opinion has changed in the management of rivers in recent years, but these measures are still not common practice.

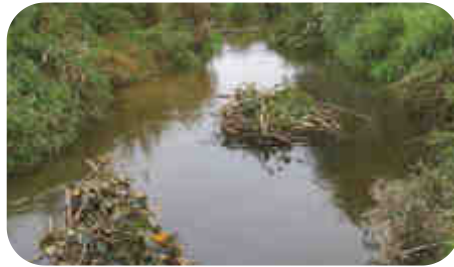
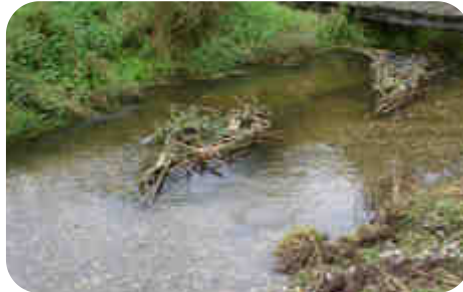
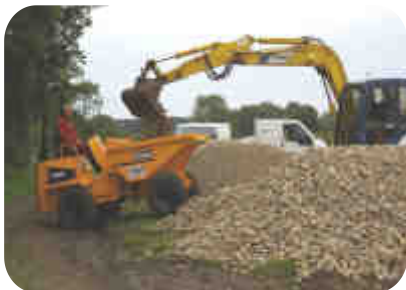
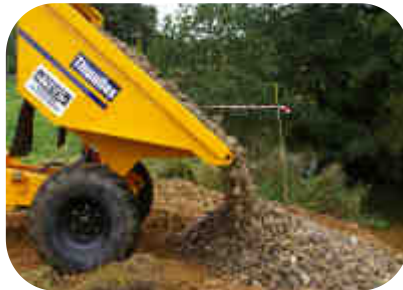
Construction of mid stream islands, completed islands and riffle constructed around them

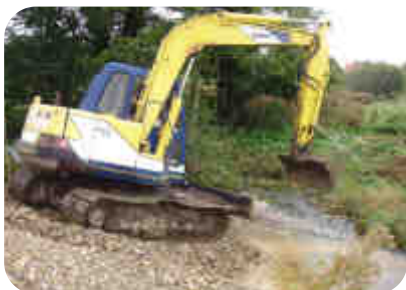
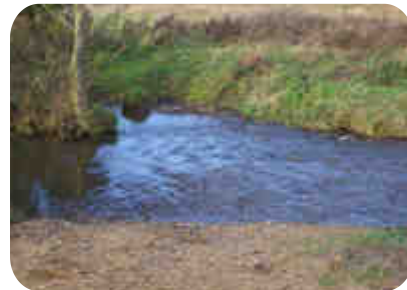
Construction of cattle crossing and riffle

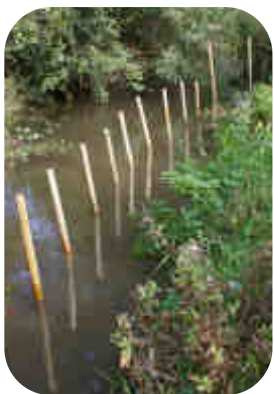
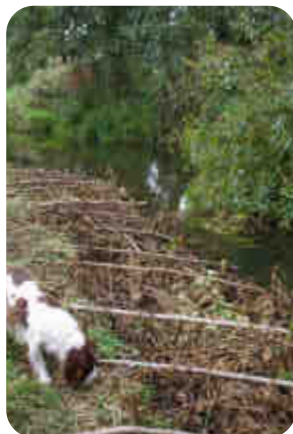
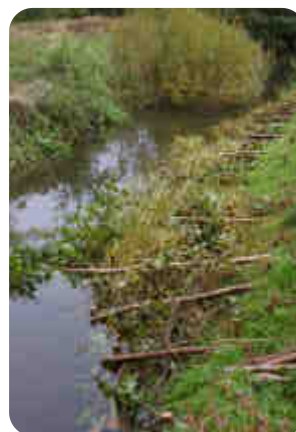
Preparation for river narrowing and finished work showing new profile of river.
