# A CINDERELLA RIVER: THE RIVER GLAVEN CONSERVATION GROUP (RGCG) IN-RIVER HABITAT RESTORATION 2006

*The River Glaven is a small chalk river in north Norfolk. The headwaters are at Lower Bodham and Baconsthorpe. The river flows for some 17km, first in a south-westerly direction, then turning to the north before finally entering the sea at the tidal sluice at Cley. The gradient is steep for a lowland river. Historically there were 11 water mills on the Glaven. Today five mill structures remain and that at Letheringsett is still in operation. The RGCG undertook a river restoration project upstream of Letheringsett Ford, between TG 060383 and TG 057376. Most of the practical work took place in October 2006, but there was a spread of tasks through September to November.*

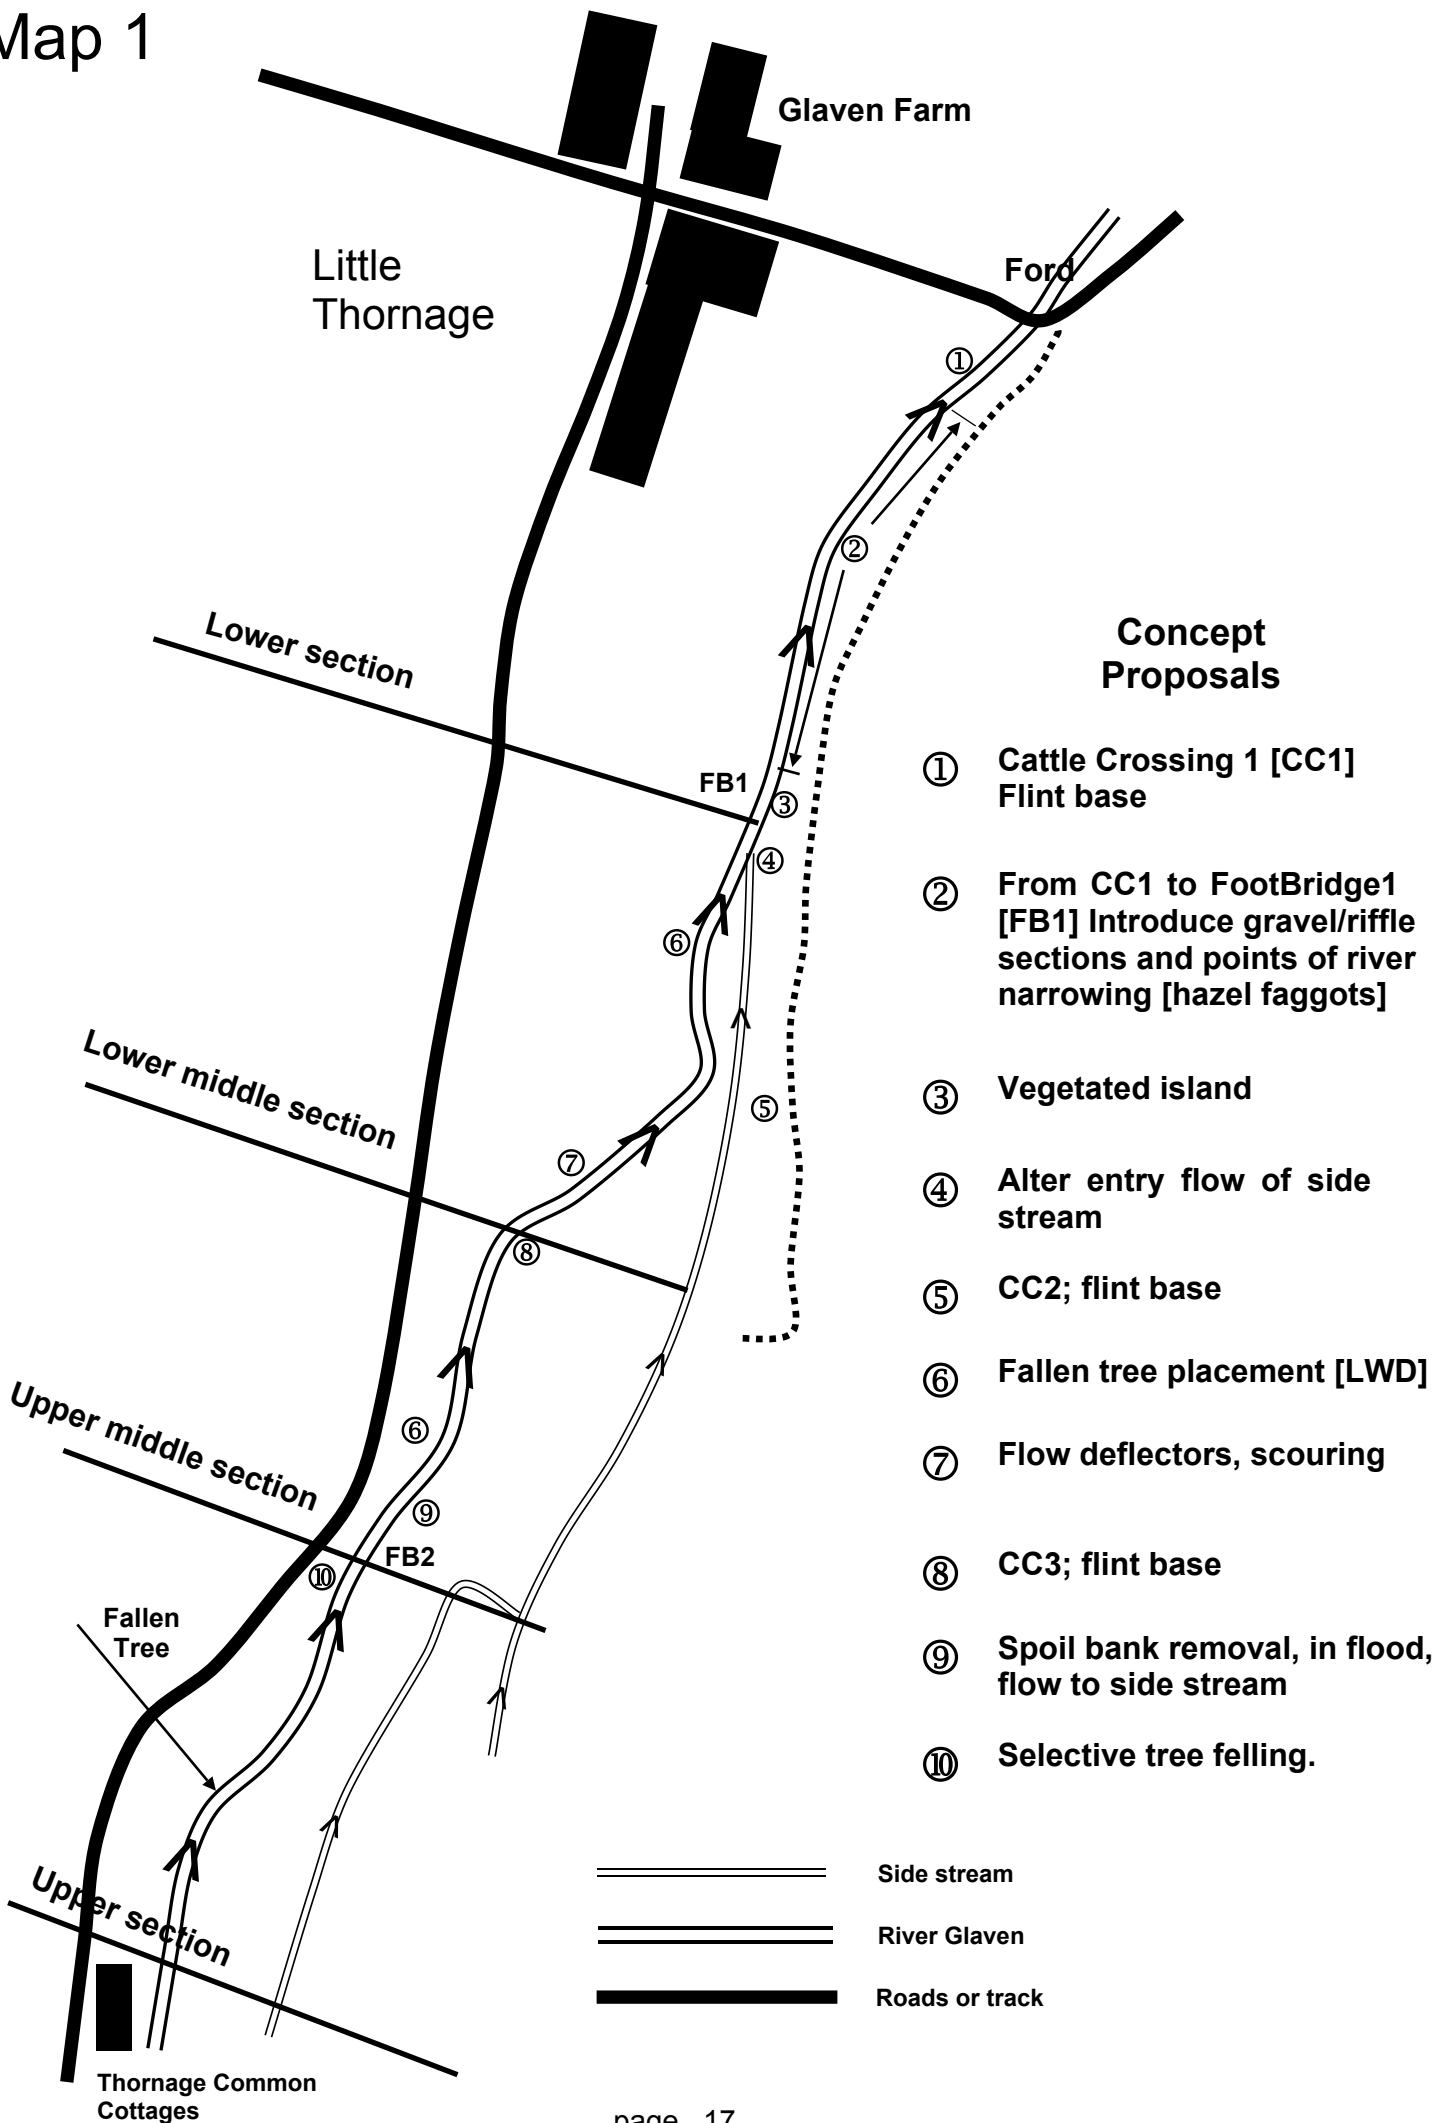
# Map 1

The lower section of the stretch runs from footbridge 1 (see map 1, page 17) down to the Ford. Here the river profile has flattened. The flow is slower, and a sand silt deposit over the gravel dominates. The flow is also slowed by the river being too wide in places. The emphasis here is to carry out some narrowing in places, and also to introduce some gravel riffles. The riffles are beneficial to trout and invertebrates as noted above; and we would hope that they extend the amount of habitat available to four species all recorded in the vicinity of the Ford; bullhead, stone loach, brook lamprey and white-clawed crayfish.

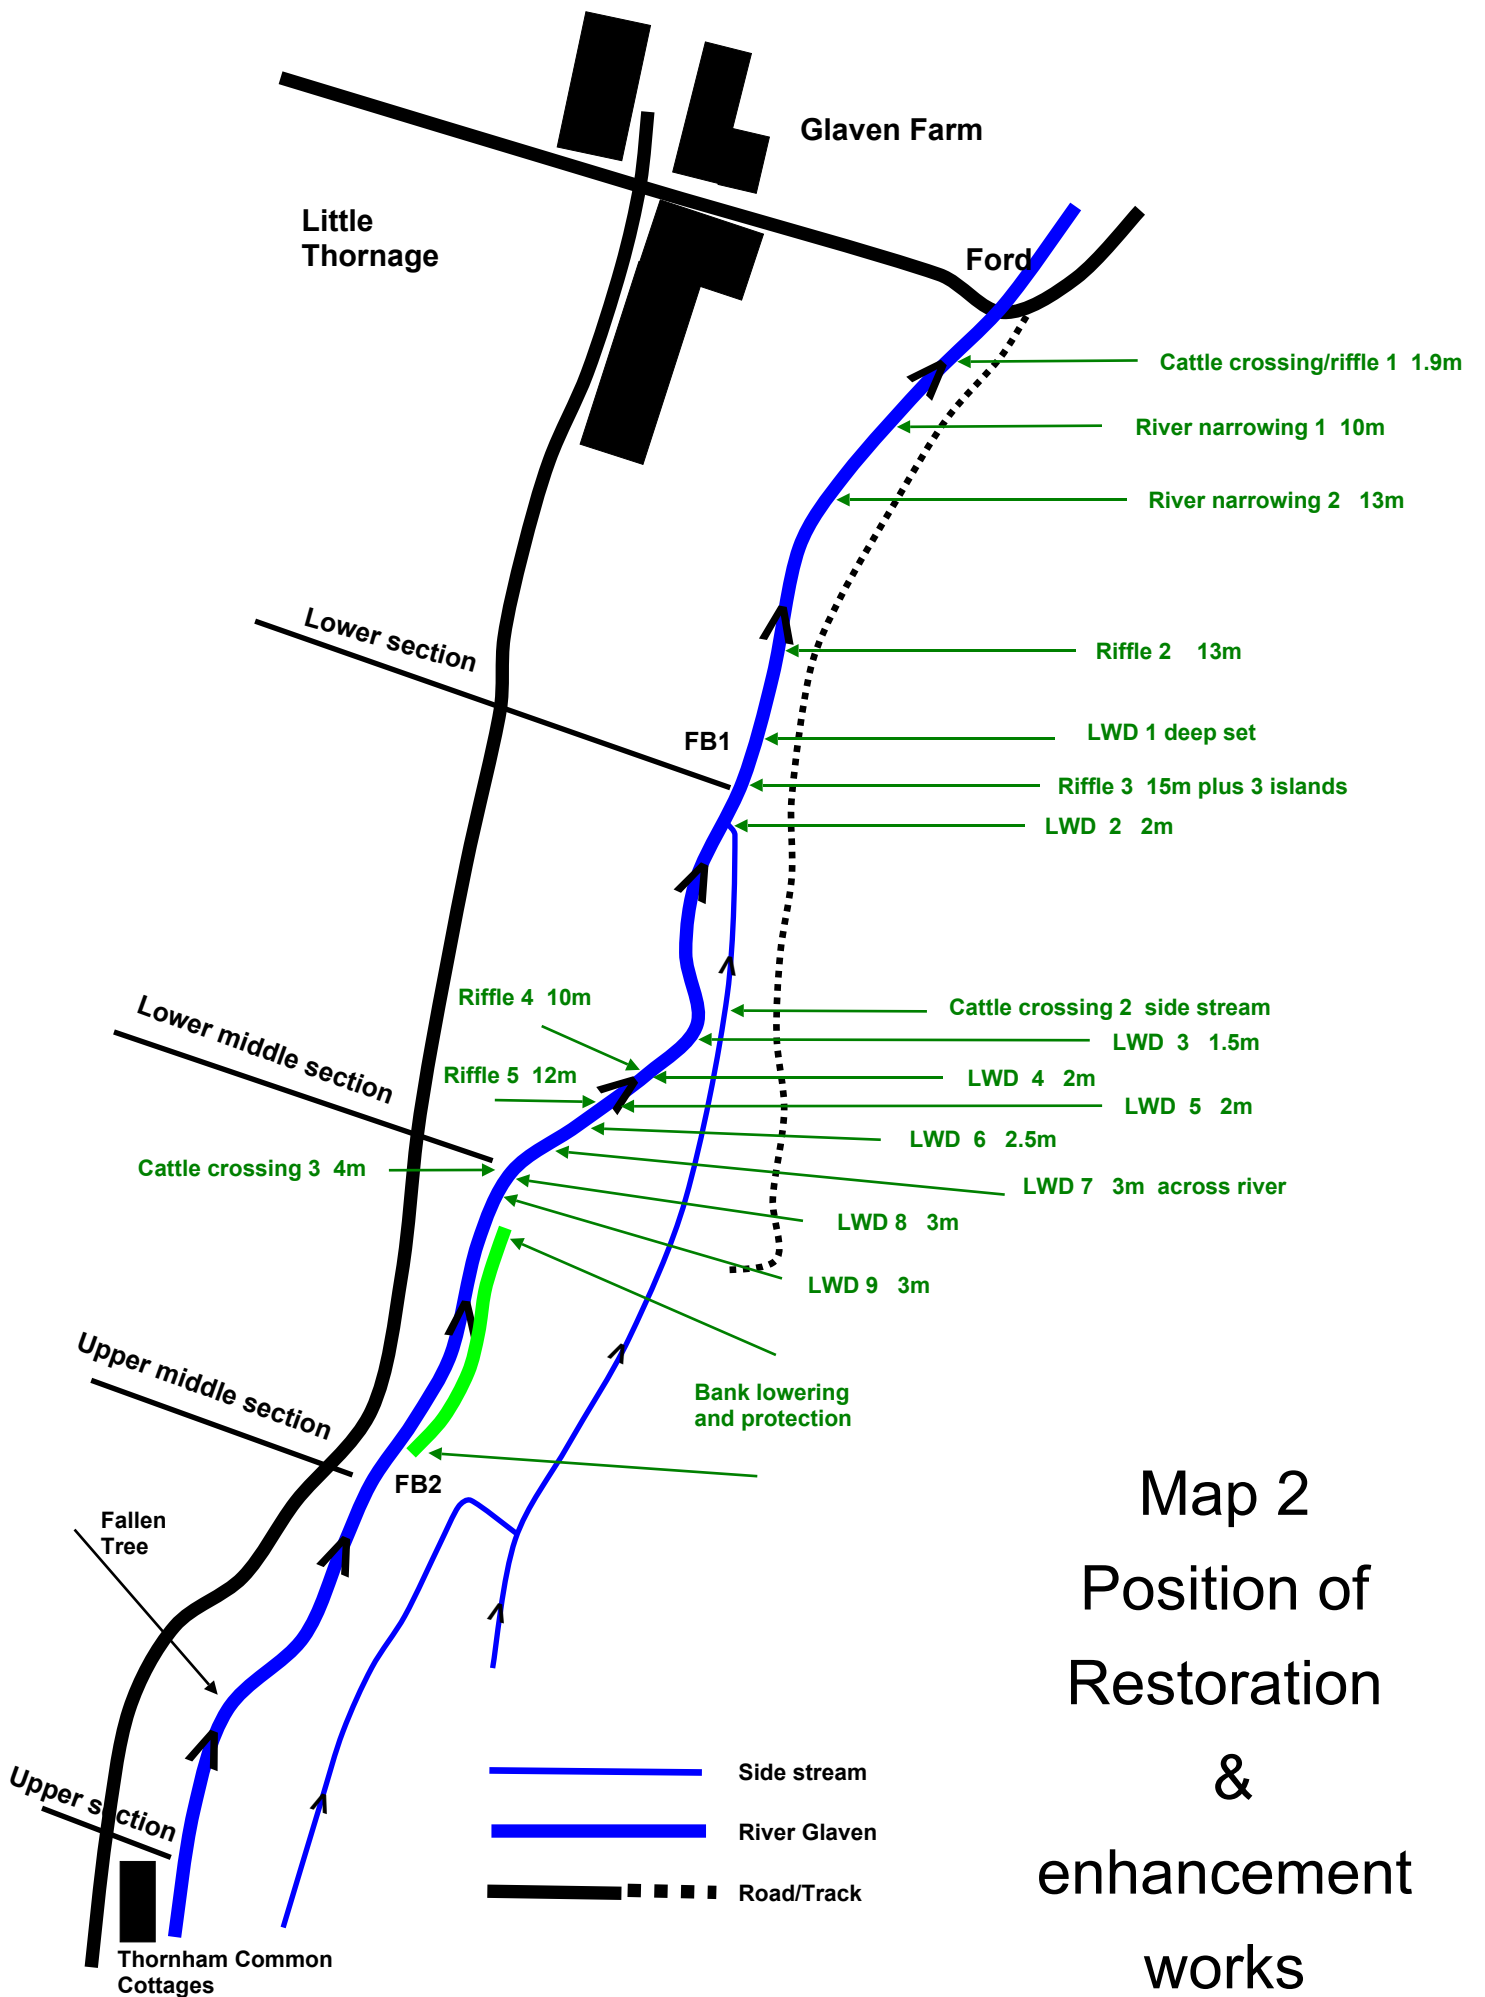
The deeper the river section, the more reject flint required. The positions of the riffles are shown on map 2, page 18, which shows the location for all the finished works.

Map 2 shows the position of the two constructions. The plan for a third length of river narrowing just upstream from the ford was abandoned as the river bed proved to be just too hard to drive in the stakes, even though a two-handled heavy metal post “thumper” (drivall) was being used for this task.

The meadow terrain can withstand heavy plant operating on the strip between the east side of the river and side channel and the hedge running between the meadow and the farm track (see map 2, page 18) in reasonably dry weather conditions. When operating to the west side of the side channel, heavy plant has to move material close to the river bank, which through the deposition of dredged material over the years is higher and drier than the meadows as a whole.

Three mid-stream islands were constructed near footbridge 1 (see map 2). The method of construction was similar to the river narrowing work, and in time the structures would develop as islands with vegetation. The top level of the islands were planned to be 150-200mm above water level.

Sections of tree trunk were placed in nine different parts of the river, all in or close to the lower middle section (see map 2). The purpose of these is to promote the scouring of the river bed in relatively homogeneous areas, and create high physical diversity within the channel. Past practice of removing all naturally occurring woody debris has an adverse impact on juvenile and adult trout. LWD create simple flow deflectors and provide deeper pools used by adult fish, and smaller pools and shelter areas also. The tree section is orientated to reduce bank erosion and secured by staking and wiring. All sections point upstream.
